ATEX Airlamp Model numbers A-TL45B A-TL44B, A-TL45A and A-TL44A

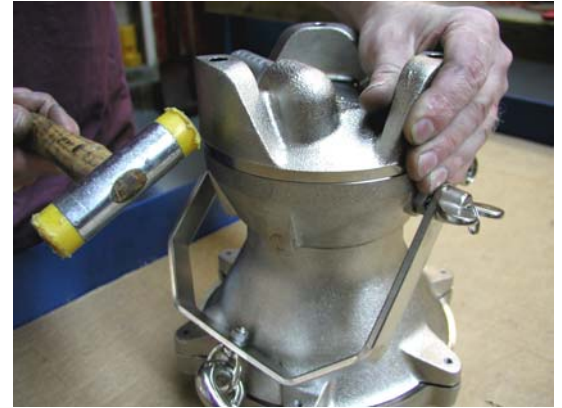
In order to inspect and maintain the Airlamps the rear cover must be removed. See Maintenance instruction for assembly break down. When the three housing cover screws (A-18) have been removed the cover will need to be removed with the help of light tapping with a plastic or hide mallet. This is because the bearing in the generator housing has an adhesive on the outer ring. Do not use a tool to prise cover as this may damage castings.

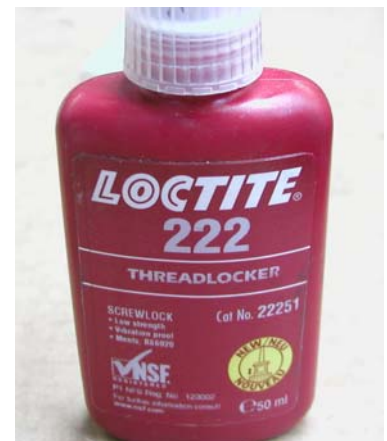
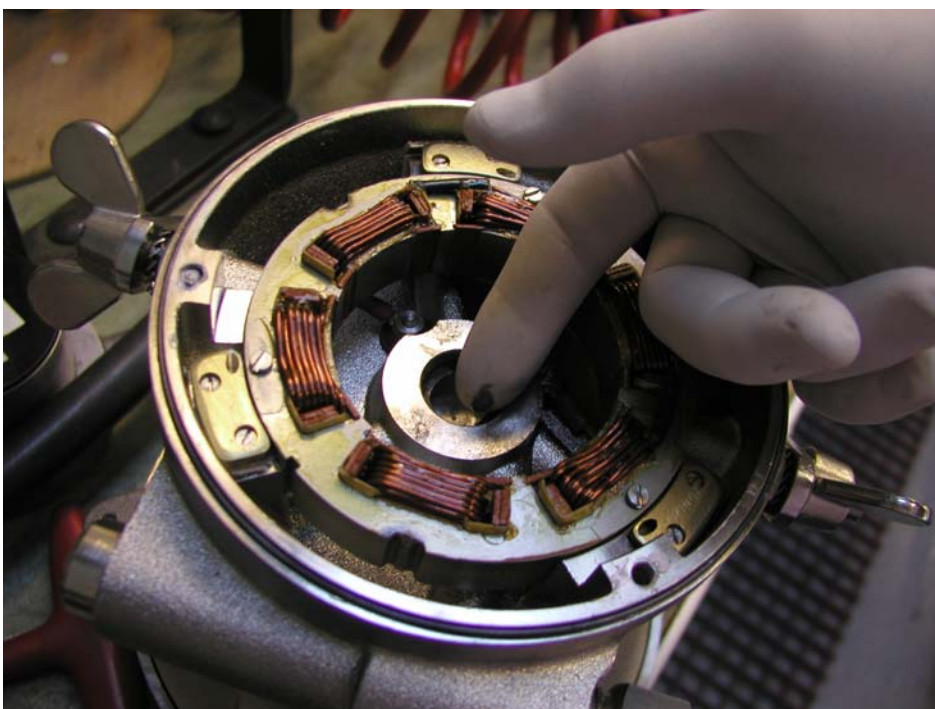
When reassembling the lamp ensure the bearing outer race and the generator housing bearing bore are clean. DO NOT USE abrasive cleaners. A small amount of loctite 222 or equivalent thread-locking adhesive should be applied to the generator housing bearing bore.
